Seaspray Flood Study - Summary Report (R05)

May 2016

| Project Name | 3569-03 Seaspray Flood Study |
| Client | West Gippsland Catchment Management Authority |

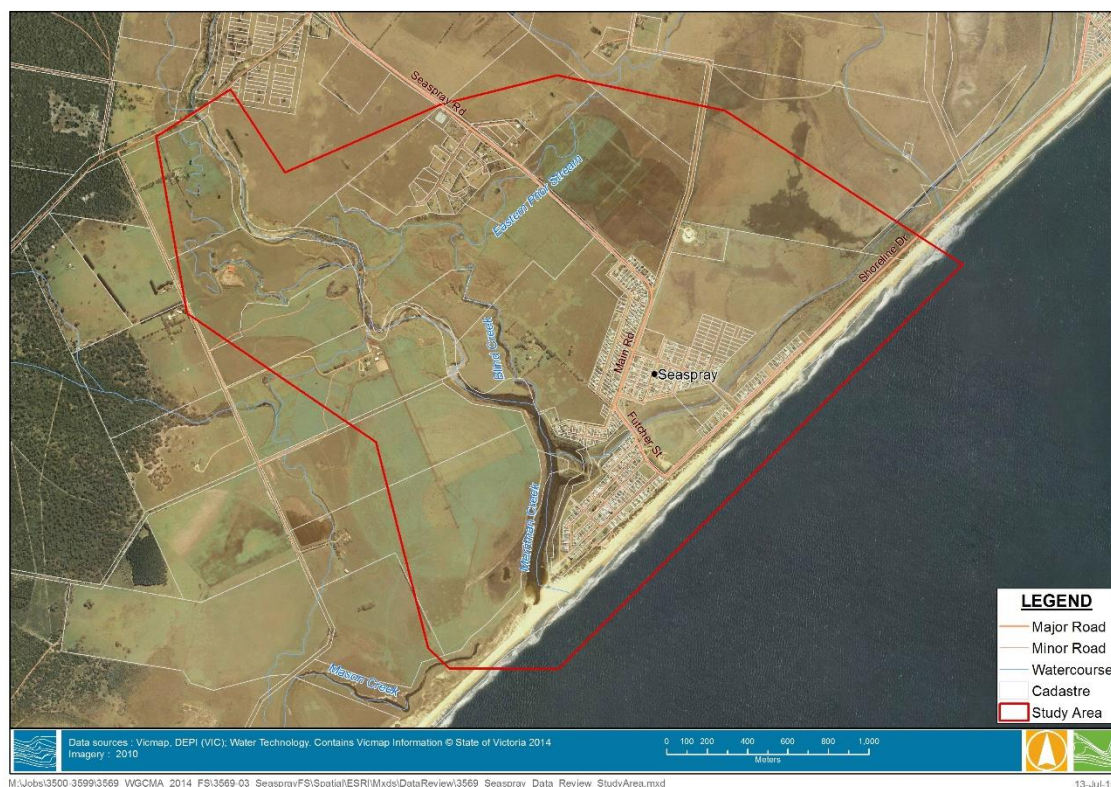
Figure 1-1 Study Area

The study area includes Merriman Creek downstream of Prospect Road, the lagoon entrance with Bass Strait, and the floodway extending all the way to the western end of Lake Reeve as shown in Figure 1-1.

The model extent covered the full study area, as shown in Figure 1-1, and inflows were included from Merriman Creek, as well sensitivity tests with flows from Lake Reeve. Ocean levels provided the downstream boundary of the model. Topography data was provided by LiDAR and field survey.

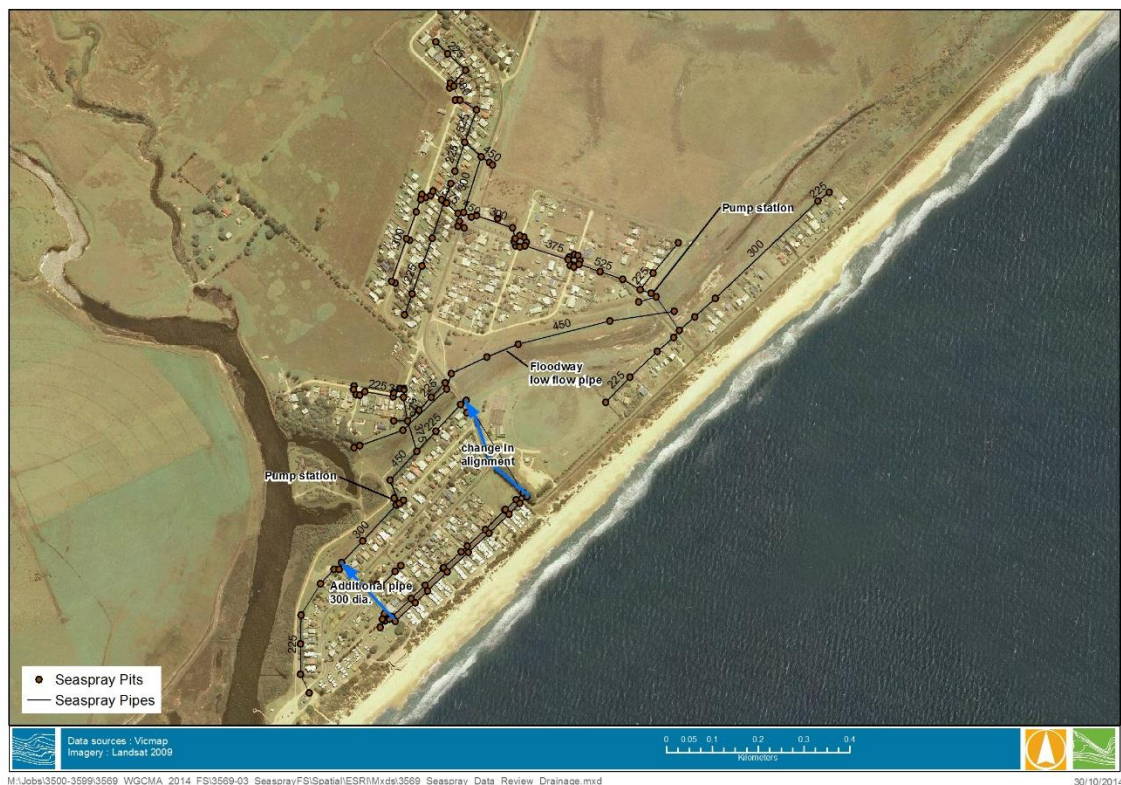
Figure 2-2 Drainage system at Seaspray

GIS layers of local pits and pipes were provided by Wellington Shire (Figure 2-2). The town of Seaspray is divided into two separate drainage areas. The area east of Fletcher Road drains to a pump station on Centre Road on the northern side of the floodway, which pumps stormwater out to the floodway. The area west of Fletcher Road drains to a pump station on Irving Street, which pumps to Merriman Creek. Each pump station has two pumps which have a maximum capacity of 170 L/s each. During a high rainfall event both pumps can be operated together giving a maximum discharge rate from each pump station of 340 L/s.

The caravan park has been constructed recently on the site of the former oval and has significant internal drainage infrastructure, including grated pits and pipes running along internal roads, and two retarding basins. Details of the caravan park infrastructure including pit and pipe layout, and detention basin locations was provided by Wellington Shire Council.

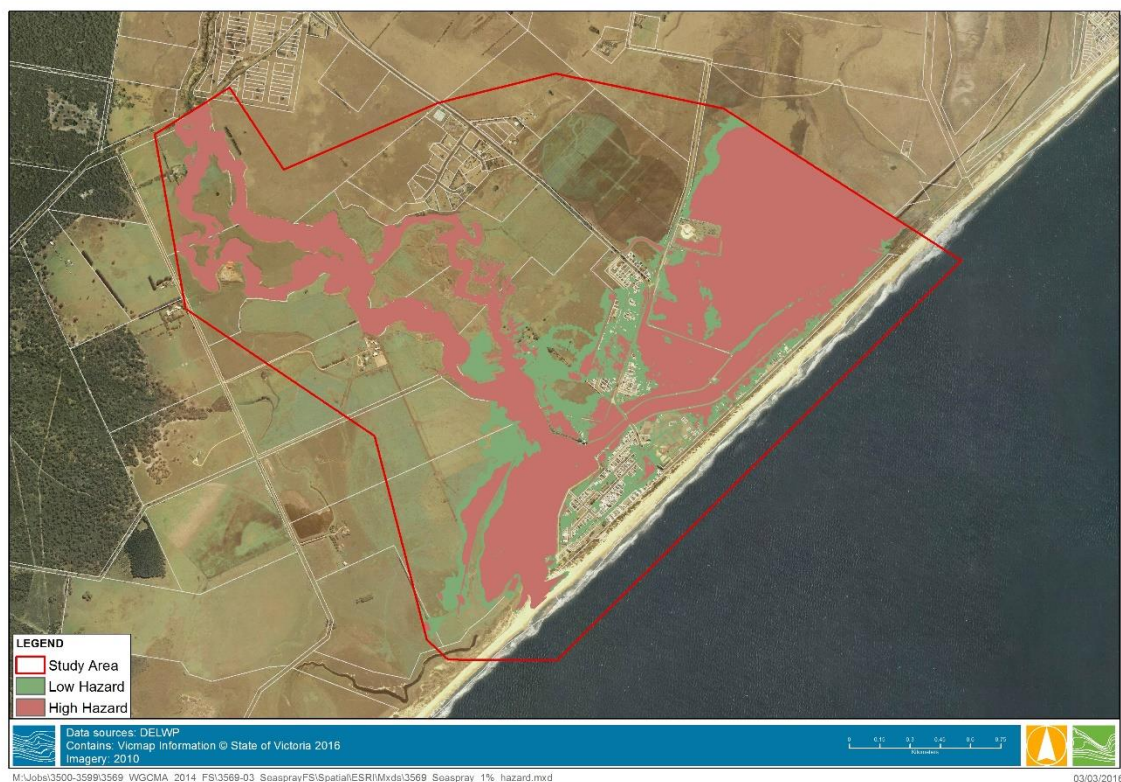
Figure 5-1 High and Low Hazard Areas in the 1% AEP flood event

The method used to delineate high flood hazard is broadly based on the new Australian Rainfall and Runoff Project 10 'Appropriate Safety Criteria for People'. Criterion for delineating the flood overlay considers both vehicle and people safety, and are as follows:

- Depth > 0.3 m
- Velocity > 1.5 m/s
- Depth x velocity > 0.3 m²/s.

If any of the above criteria is exceeded, the area is considered to be High Hazard. Low Hazard areas are locations within the flood extent, but do not exceed any of the above criteria. The maximum flood hazard for the 1% AEP flood event is shown in Figure 5-1.

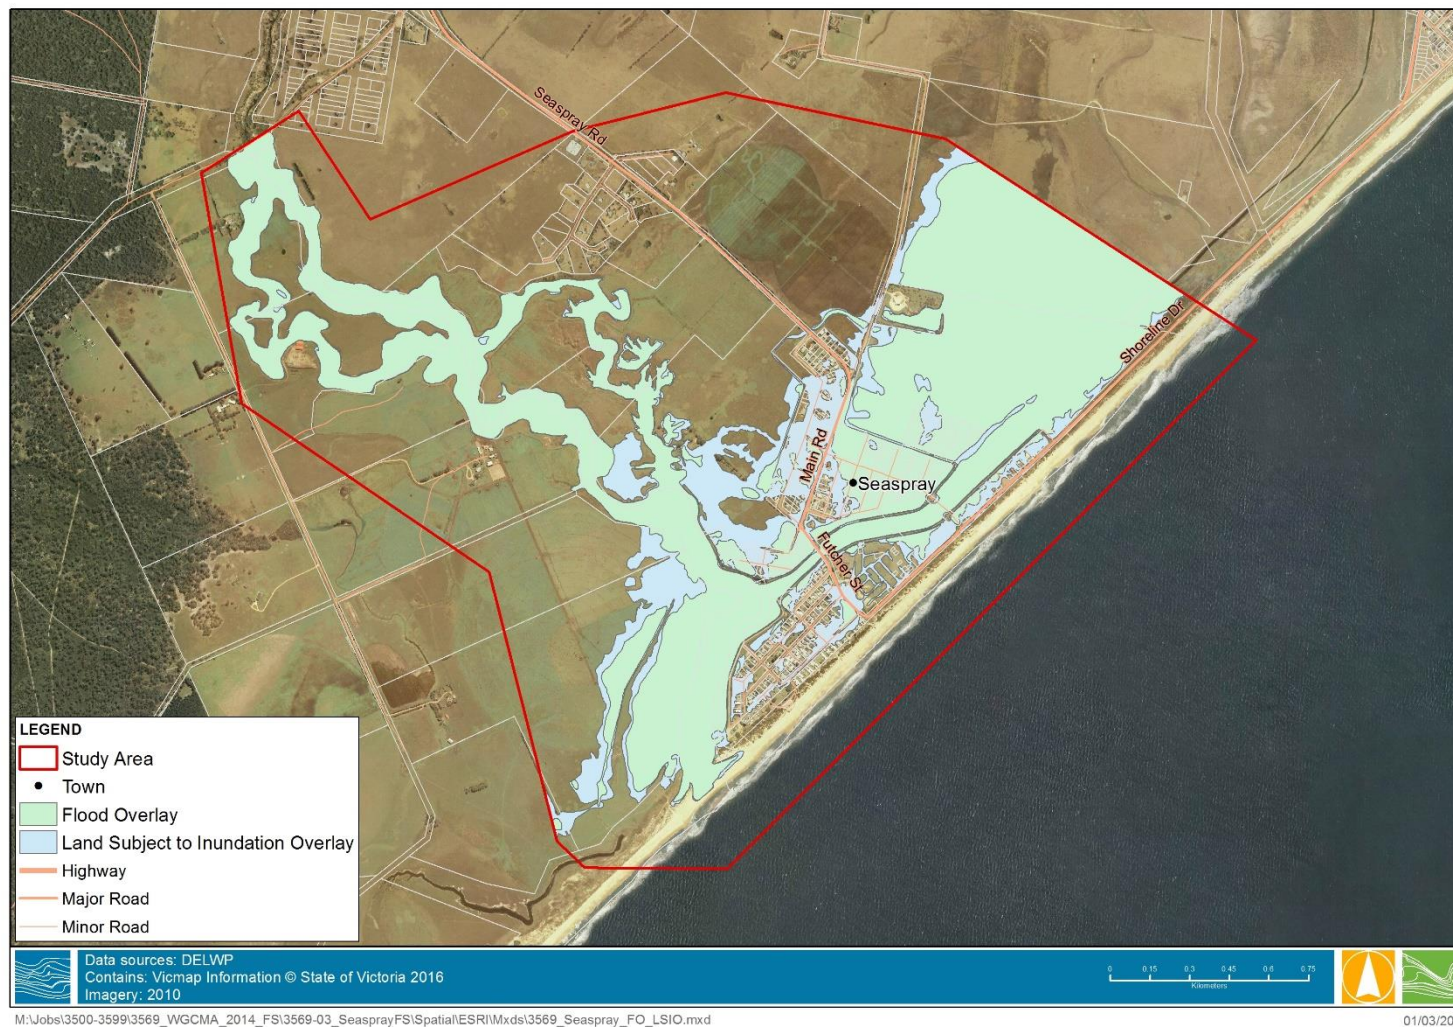
Figure 5-2 Draft LSI0 and FO Map for Existing Conditions

For the study area, FO and LSIO overlays have been developed based on accepted safety criteria (refer Report 4 for details). The resultant draft FO and LSIO maps are provided in Figure 5-2.

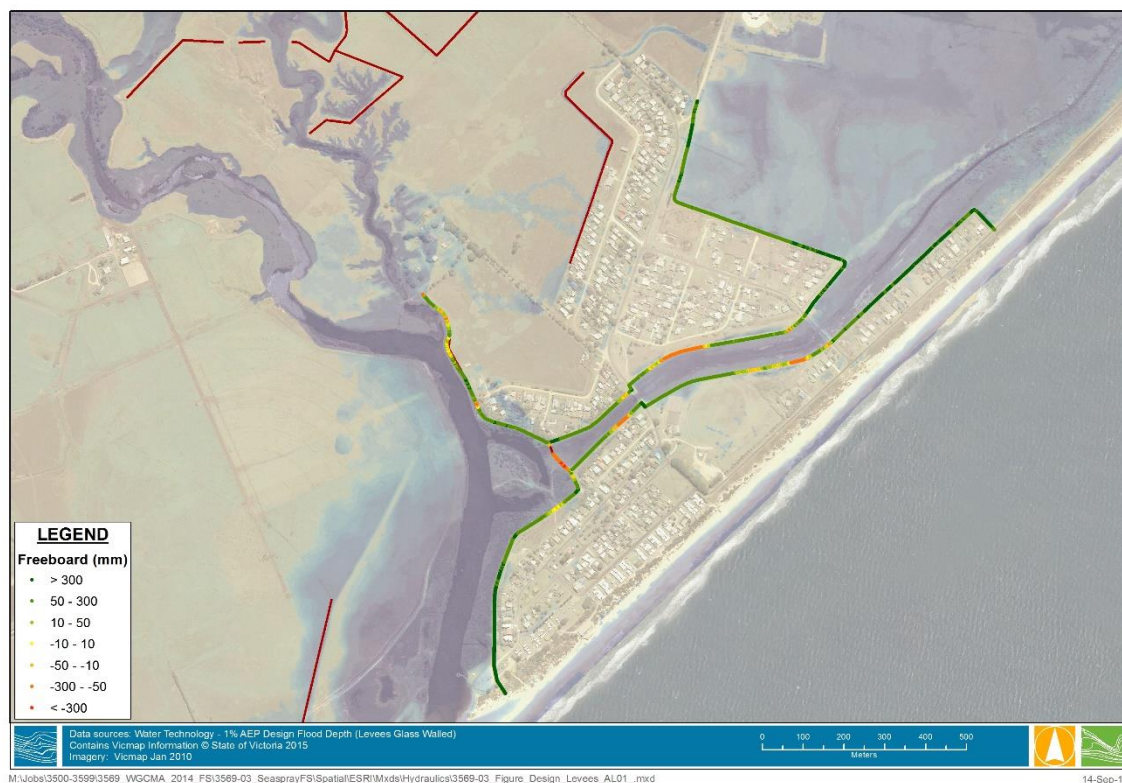
Figure 5-3 Vulnerability of existing levees in the 1% AEP flood event

The levee assessment (Option 3) has identified locations across the levee network in and around Seaspray that are vulnerable to overtopping (Figure 5-3) and how much the vulnerable sections of levee should be raised to provide the required level of flood protection. This work allows a targeted approach to raise underperforming sections of the levee and improve the levee network to mitigate flood levels in the 1% AEP flood event.

Flood Risk Treatment & Mitigation – locations along the existing levee network that are vulnerable to overtopping in the 1% AEP flood event have been identified. A targeted approach to raising vulnerable sections, in addition to an extension of Griffioens Levee along the bank of Blind Creek, can result in significant reduction of flood damages for the 1% AEP flood event.
