AGRICULTURE VICTORIA

Effluent application through a pipe and riser system

West Gippsland
Catchment Management Authority

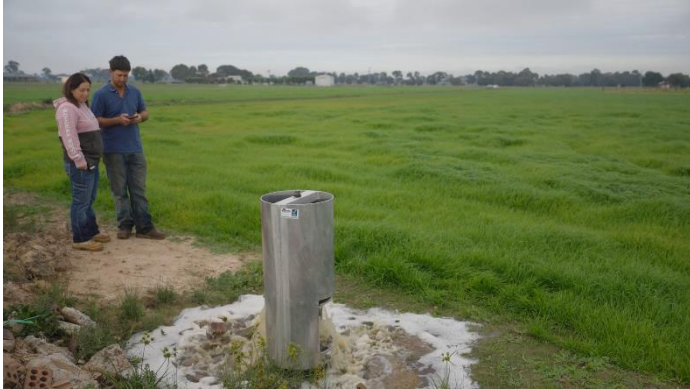
Effluent injection into pipe and riser systems combined with soil testing has enhanced nutrient management, avoiding environmental impacts.

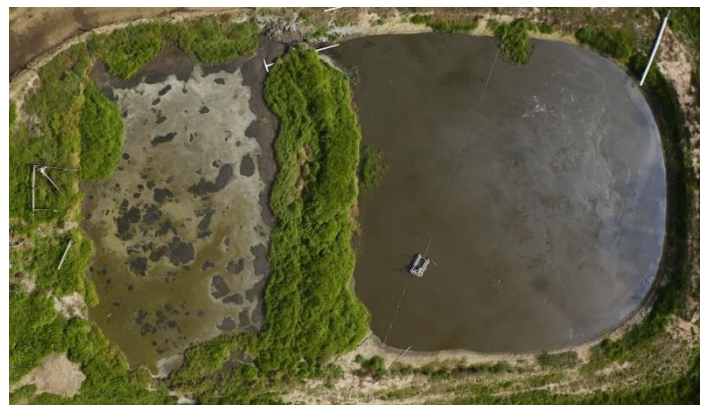
Figure 1, Steve and Jess' two pond effluent system, linked to their pipe and riser infrastructure.

To this end, they developed a two pond effluent storage system, and completely stopped putting effluent on the paddock close to the dairy that had been the historical disposal area.

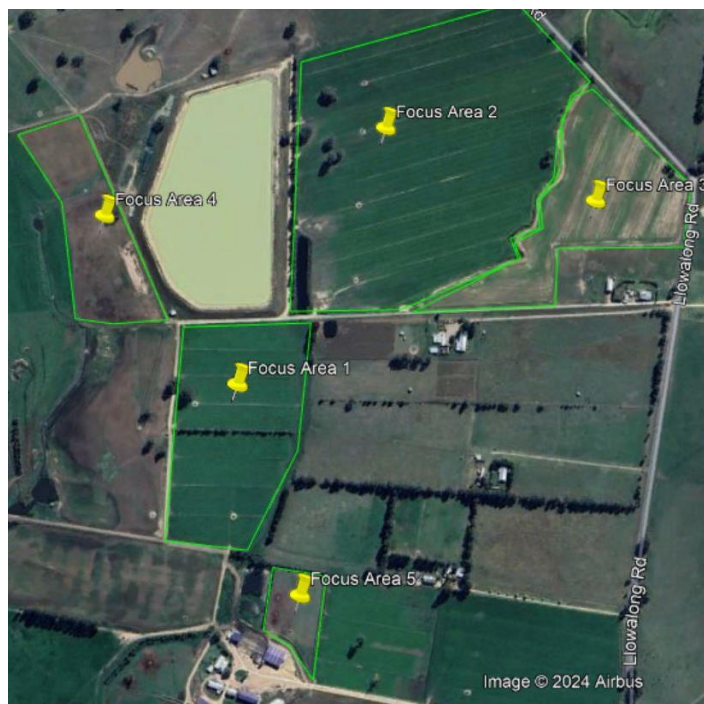
There are 5 focus areas on the farm that have been soil tested for the 12 months of the project. These focus areas are outlined in Figure 3 below, with the following treatment conditions:

1. Two years of effluent application
2. One year of effluent application
3. Zero years of effluent application (started in 2024 season)
4. Control area – no effluent application
5. Area with a long history of effluent application

Figure 2, Focus areas that have been subject to soil testing over the 12 months of the demonstration project.

The five focus areas were soil tested as follows: to a depth of 0-10cm at the start of the project, midway, and end of the project. Soil testing to depths of 10-30cm and 30-60cm also took place at the start and end of the project.

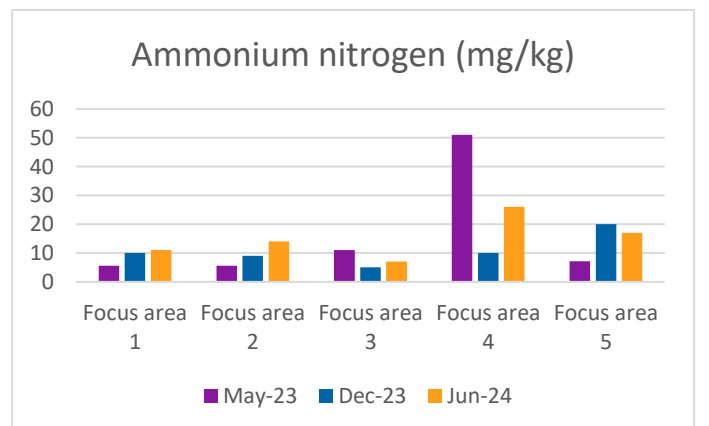
Figure 6, Concentrations of ammonium nitrogen across the focus areas

Recommendations from a local agronomist were that nothing but effluent needed to be applied to the areas in the trial, and even then, only for the nitrogen content (figures 5 and 6). The exception to this was focus area 5, which must have nothing applied to it and needs to be mined of nutrients for several years yet due to the extremely high levels of nutrient already present.

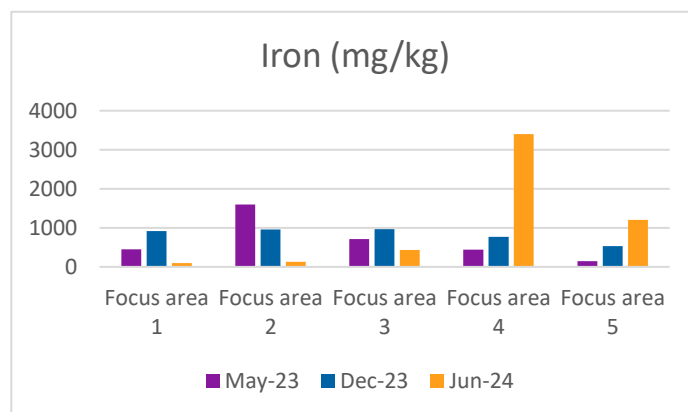
Figure 9, Concentrations of iron in plant tissues across the focus areas

Boron was the only nutrient that tested lower than optimum in all areas and may need to be strategically applied to increase the levels in the soil and the plants. Iron was particularly high in the plants (figure 9), which may be related to waterlogging caused by recent flooding events experienced in late 2023 and early 2024.

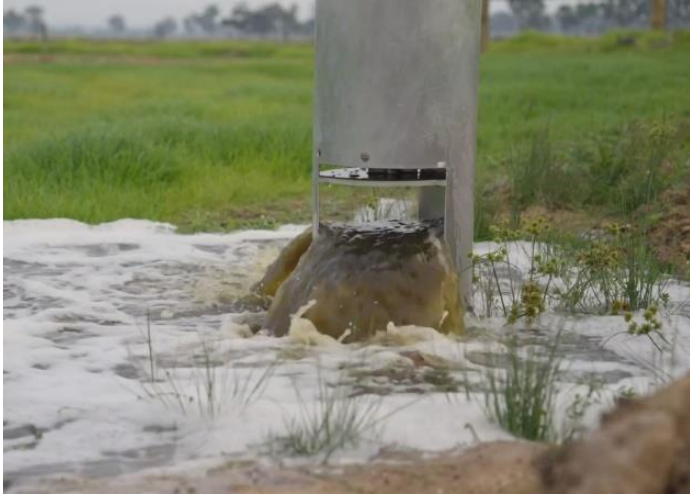
Figure 10, A pipe and riser outlet irrigating effluent water onto focus area 3, which had never had effluent applied to it.

The effluent testing at the start and end of the project showed minimal change in nutrient levels, with most nutrient at optimum levels. The pH was in the neutral range, which is an advantage for irrigating Steve and Jess's soils with effluent (figure 10) as they are slightly acidic (pH between 4.7 (never had effluent) and 6.9 (the historic effluent paddock)).

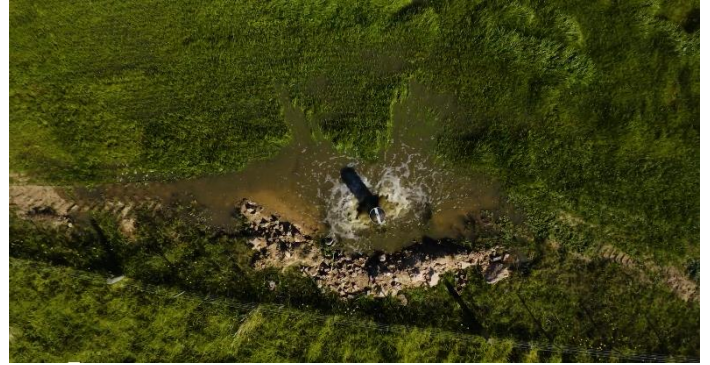
Figure 11, Aerial view of the pipe and riser irrigating the lush pasture in focus area 3 with injected effluent.

The benefits of these practices are that nutrient is only applied where it is needed, such as focus area 3 (figure 11), and both effluent and artificial fertiliser will not be at risk of being washed away as runoff into the creeks and the Avon River, or lost below the root zone.
