AGRICULTURE VICTORIA

Effluent application through centre pivots using a self- cleaning filter

West Gippsland
Catchment Management Authority

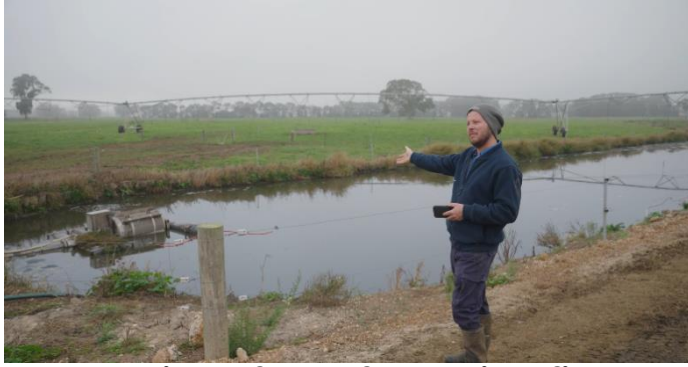
Installation of a self cleaning filter on the Gannon farm has enabled effluent water to be utilised through centre pivot irrigation systems.

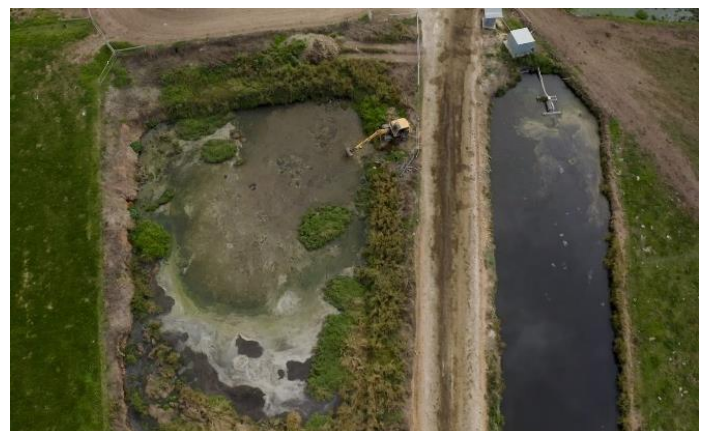
Figure 1, Tom's two pond effluent system.

This had enormous benefits on farm for irrigation efficiency, but it also created a problem of how to dispose of the dairy effluent kept in the two pond system on farm (Figure 1).

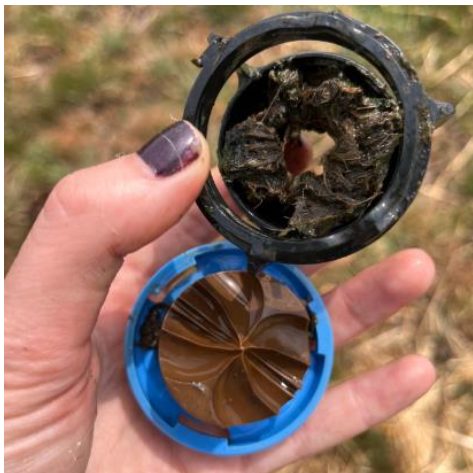
Tom found that very fine grass particles in the effluent constantly blocked the filtration system on the effluent pump. This caused a pressure drop at the pump, which then lowered the supply pressure for the centre pivots. This caused the pivots to run at lower pressures than they were designed for, which greatly affected irrigation uniformity, or in the worst cases, caused the pivots to stop running altogether. The grass particles would also block the sprinkler heads on the centre pivots, depicted in Figure 2, which further affected uniformity.

Figure 2, One of the nozzles on Tom's pivot showing blockage by effluent particles.

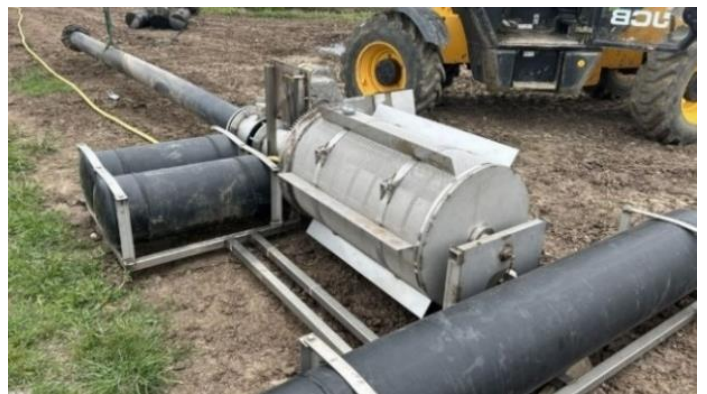
The focus of the project was a self-cleaning pontoon filter on the suction line of the existing effluent pump. The barrel has very fine mesh to stop grass particles entering the suction line, and a rotating self-cleaning mechanism to ensure that any solids adhering to the mesh are deposited back into the pond. The filter was installed in November 2023 by a local supplier at a cost of \$28,000 (Figure 3).

Figure 3, Tom's pontoon filter ready for installation in November 2023.

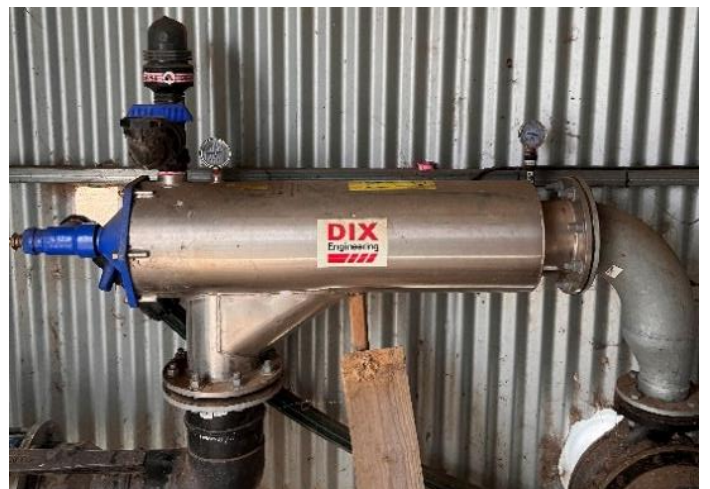
An inline filter (Figure 4) was also installed by a local supplier, in May 2023, at a cost of \$10,500. This automatically filters, brushes and backflushes as grass particles build up. This was intended as a failsafe mechanism to complement the pontoon filter.

Figure 4, The secondary inline filter in situ in the pump shed.

The in-line filter was installed first, in May 2023, and provided a big improvement in system operation at that time. Tom was able to irrigate with effluent through the pivots without pressure drops or constant maintenance.

However, after repeated irrigations the filter would still block up, as there were still large quantities of grass particles coming through the suction line and pump into the filter. Tom would then have to manually clean the filter and dump the excess water before he could irrigate again.

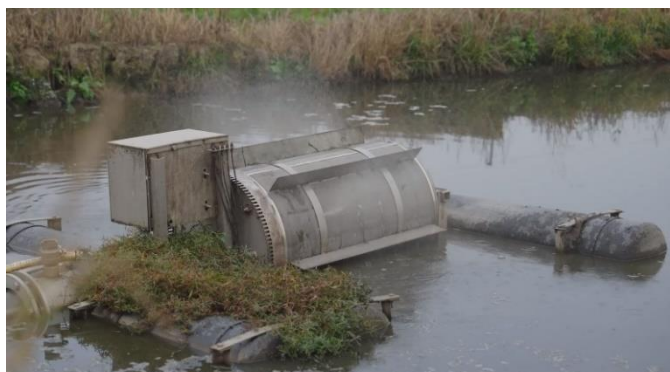
The pontoon filter was installed in November 2023 and has been a resounding success. Tom has had no blockages or pressure drops since then and has not had to clean the filter on the pump, the pivot, or any pivot sprinklers since it was installed. The inline filter has also hardly run in that time as the water is much cleaner.

Figure 5, Tom's pontoon filter working effectively.

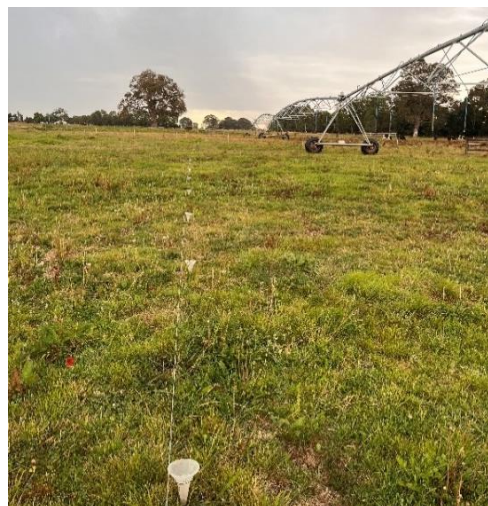
Pivot assessments were undertaken before and after the filters were installed, to compare the effects of improved filtration. These assessments involve measuring water pressure, and sprinkler output using catch cans (Figure 7). The first pivot assessment was completed in February 2023.

Figure 7, Pivot assessment completed by Agriculture Victoria.

Tom ensured that the pump and pivot filters and the sprinkler nozzles were cleaned before the irrigation to give the best representative results. On starting the irrigation with effluent, pressure gauges showed a drop of 20 psi in pump pressure after approximately 10

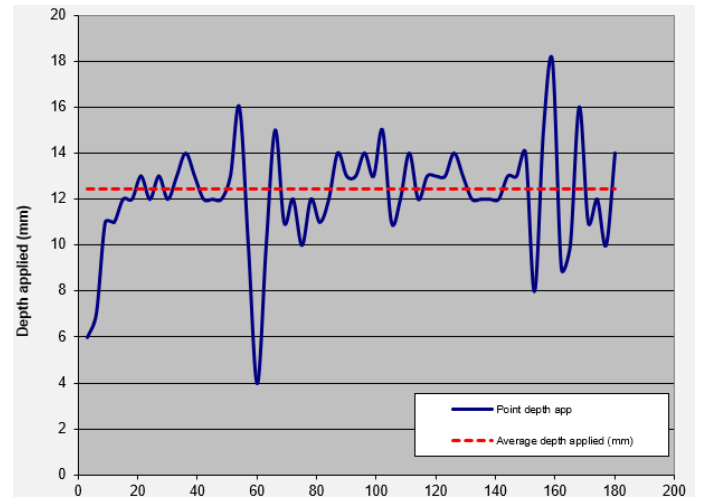
The second pivot assessment was conducted after both filters were installed, in March 2024. The results of this assessment (Figure 9) showed that the pivot was running at correct pressure due to no blockages, and the uniformity of the machine was much improved, with a coefficient of uniformity of 87%. This is an improvement of 22% uniformity following installation of the filtration system, and well above the industry standard of 80%.

Figure 9, Variability of water and effluent application depth of Tom's pivot with effective filtration

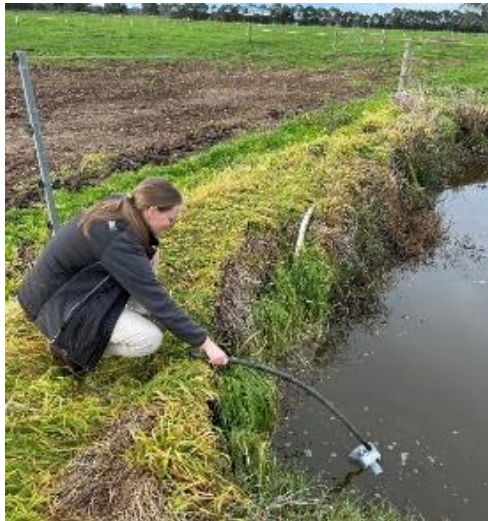
Effluent testing, shown in Figure 10, suggested no major change in nutrient levels, with all measuring as adequate or high. The effluent also did measure relatively high in salinity.

Figure 10, Effluent testing being undertaken at Tom's effluent pond.
