FLOOD RECOVERY STORIES

Glenfalloch Station

Building flood resilience, naturally

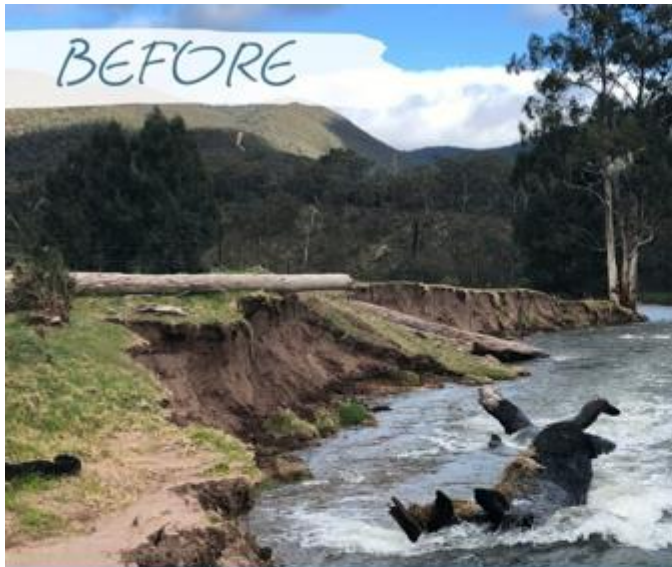
BEFORE

Wirn Wirndook Yeerung (Macalister River) swelled in the widespread June 2021 flood event in West Gippsland, leaving the waterway damaged and in need of repair.

Machinery was brought in to smooth 200 metres of raw, vertical bank into a gentle slope using a technique known as 'battering'.

Logs and woody debris washed down by the floodwater were salvaged and dug into the bank. This helped with stabilisation and also provided habitat for frogs and fish.

Finally, almost 7,000 plants were put in the ground.

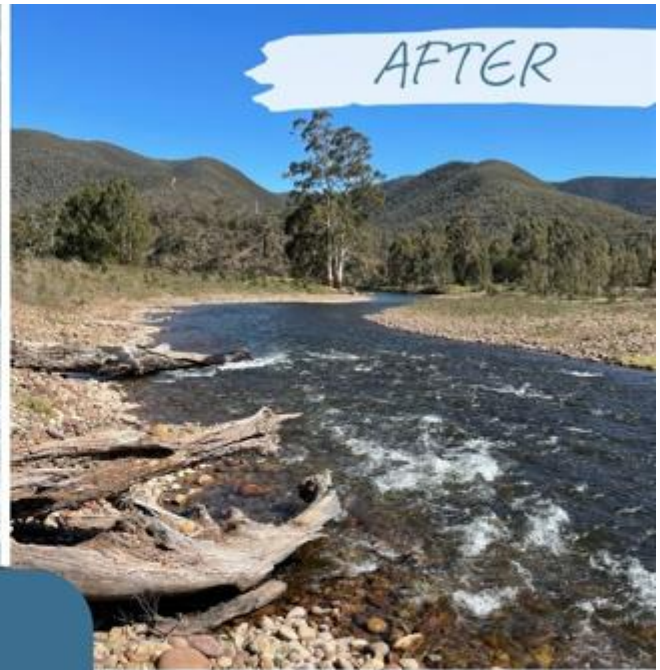
AFTER

After 18 months, the repaired sites were in a strong shape to withstand future floods.
