## FLOOD RECOVERY STORIES

*Martin Walker*

### Middle Creek making its own path

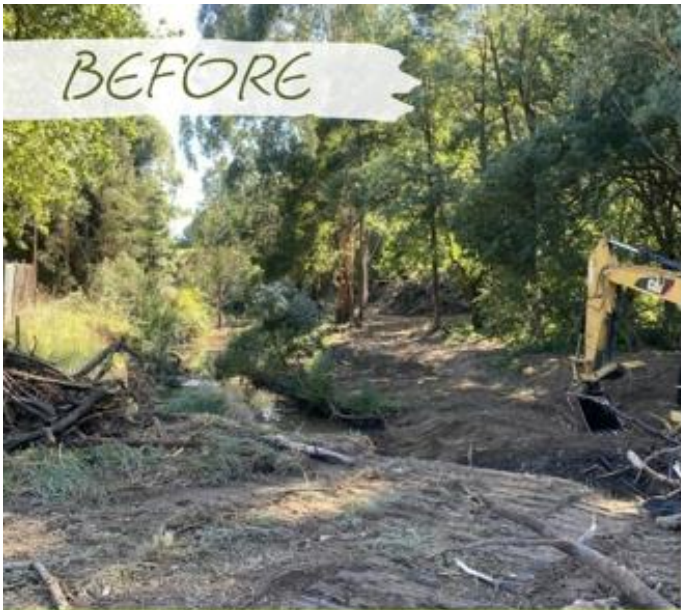
BEFORE

June 2021, the usually calm flow of Middle Creek burst its banks and forged its own path taking down trees and damaging banks in Martin Walker Reserve.

Middle Creek, which flows into Morwell River, suffered during the flood which widened and scoured its banks.

Once the area was declared safe and debris removed, rock was brought in and earthworks commenced. The bank was first battered to a stable slope before being armoured with the quarried rock. Otherwise known as 'rock beaching' this will help to prevent erosion and protect the bank in future flood events.

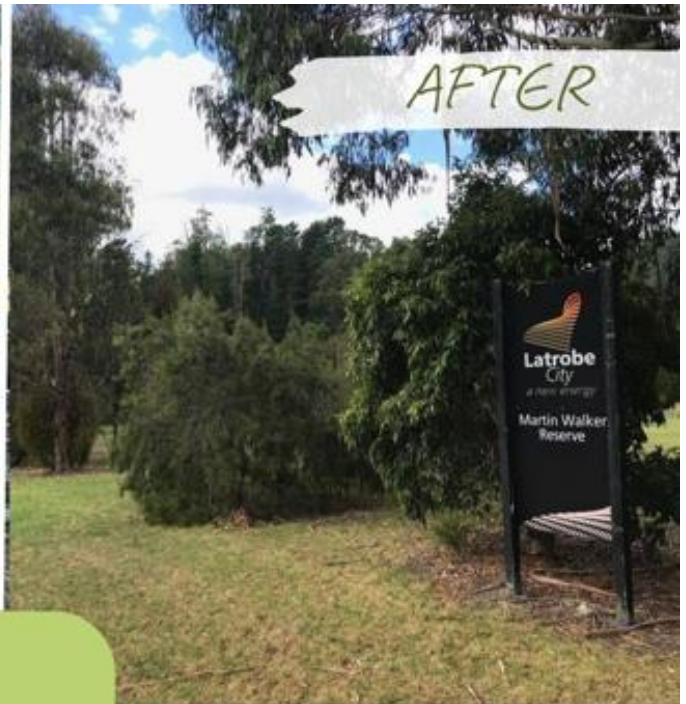
AFTER

After the banks were battered and armoured, planting helped restore the gardens for the community to enjoy.
