FLOOD RECOVERY STORIES

Noojee Reserve

New life for Noojee Reserve

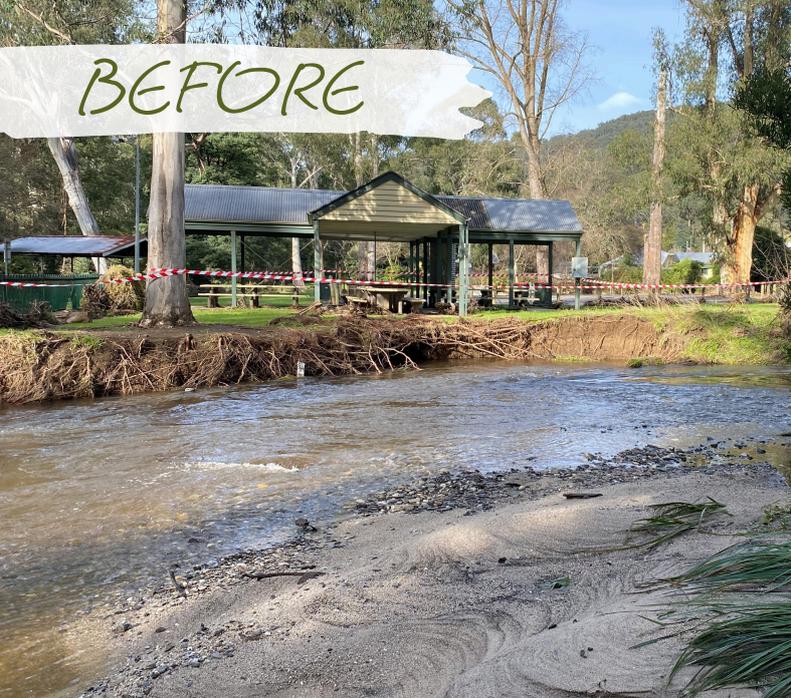
BEFORE

The Noojee Reserve is usually a tranquil spot with shelter, picnic tables, winding tracks and toilet facilities. In the June 2021 storm event, the public reserve was completely inundated as the river broke its banks and roared through the park taking out banks, trees and paths.

When the initial emergency was over and the area declared safe, the team at West Gippsland CMA moved in to assess the damage. Working in partnership with Baw Baw Shire Council, a large amount of debris covering the reserve was removed and the debris taken away.

The team used rock to repair and reinforce the banks. Local contractors worked under the guidance of the CMA to expertly stabilise the banks, armouring it to withstand future events.

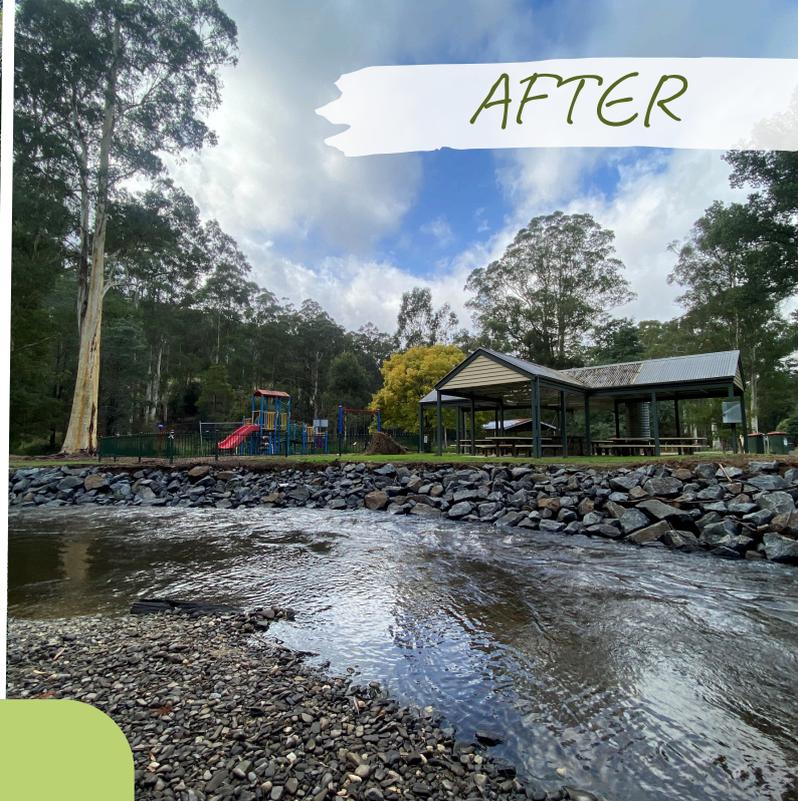
AFTER

Now the reserve is open again, the river has slowed and locals and visitors are once again enjoying fishing, walking and picnicking at this tranquil spot in the heart of Noojee.

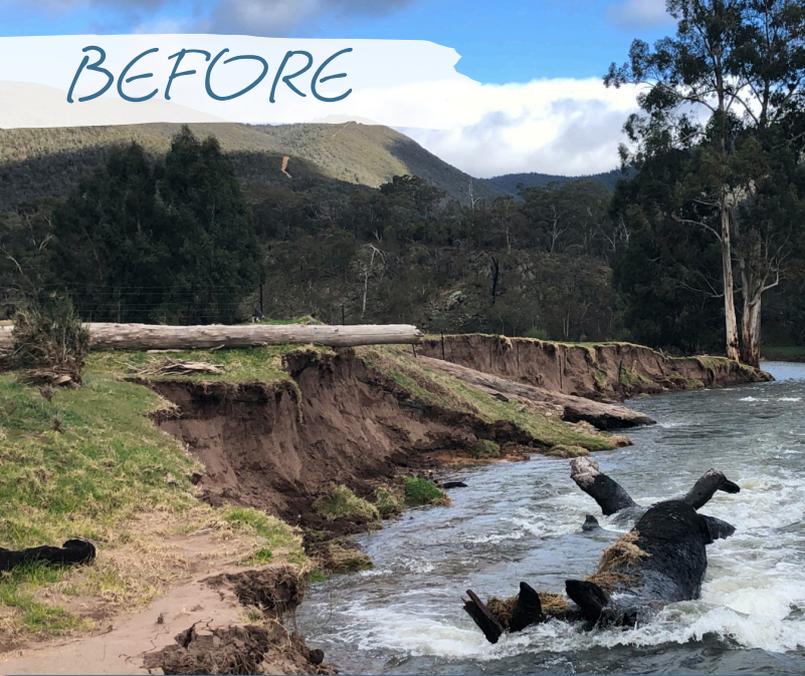
BEFORE

Wirn Wirndook Yeerung (Macalister River) swelled in the widespread June 2021 flood event in West Gippsland, leaving the waterway damaged and in need of repair.

Machinery was brought in to smooth 200 metres of raw, vertical bank into a gentle slope using a technique known as 'battering'.

Logs and woody debris washed down by the floodwater were salvaged and dug into the bank. This helped with stabilisation and also provided habitat for frogs and fish.

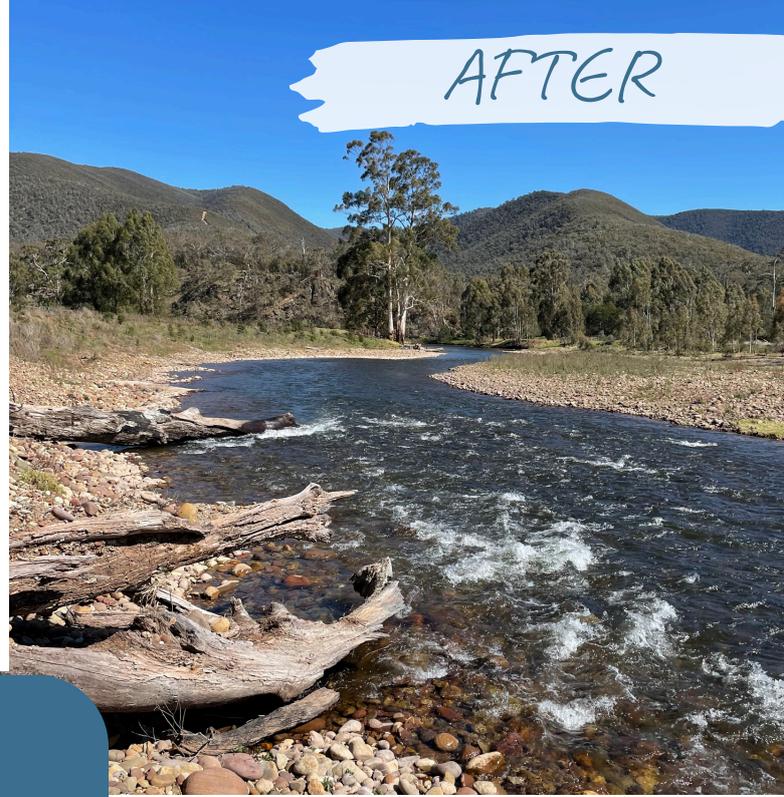
AFTER

After 18 months, the repaired sites were in a strong shape to withstand future floods.

Finally, almost 7,000 plants were put in the ground.

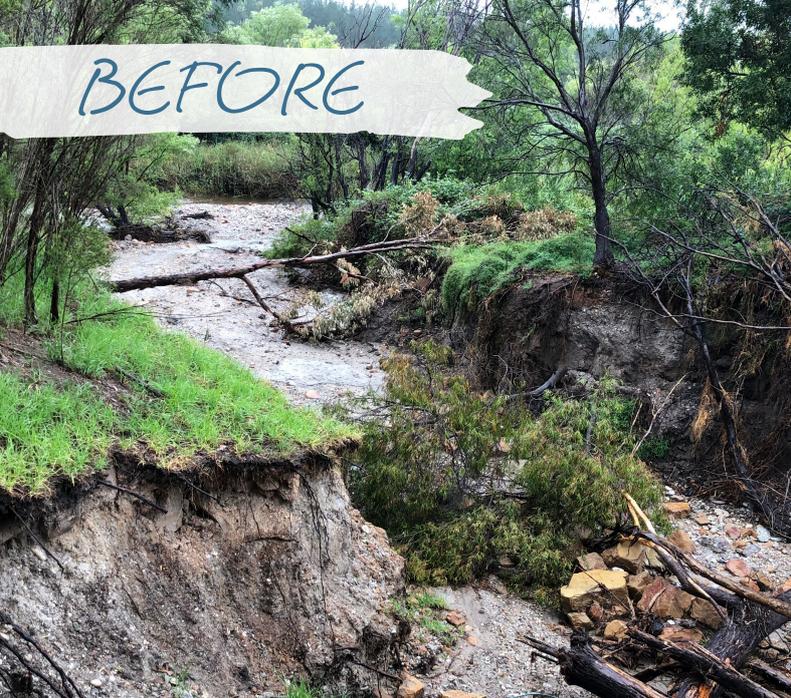
BEFORE

During the rainfall event, water rushed down an existing gully line into the Avon River, damaging vegetation, dumping a huge load of sediment into the waterway and severely eroding the bank.

Without intervention the erosion would only worsen with each rainfall event.

Large rocks were delivered and strategically positioned over the eroding gully to create a 'chute', or channel, for rainwater to flow gently down into the river.

The rock surface of the chute will protect the soil from being eroded and prevent sediment from entering the river system and flowing on into the Gippsland Lakes.

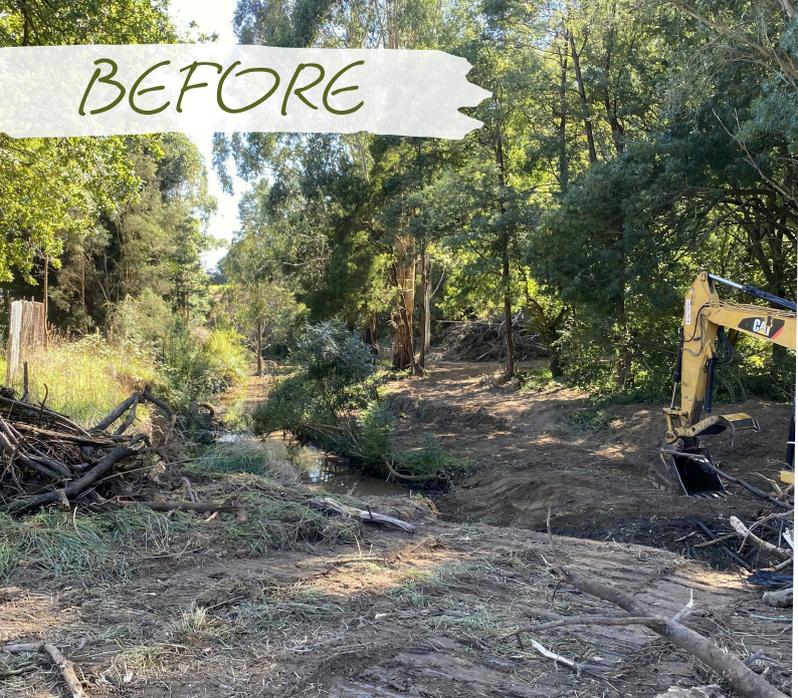
BEFORE

June 2021, the usually calm flow of Middle Creek burst its banks and forged its own path taking down trees and damaging banks in Martin Walker Reserve.

Middle Creek, which flows into Morwell River, suffered during the flood which widened and scoured its banks.

Once the area was declared safe and debris removed, rock was brought in and earthworks commenced. The bank was first battered to a stable slope before being armoured with the quarried rock. Otherwise known as 'rock beaching' this will help to prevent erosion and protect the bank in future flood events.

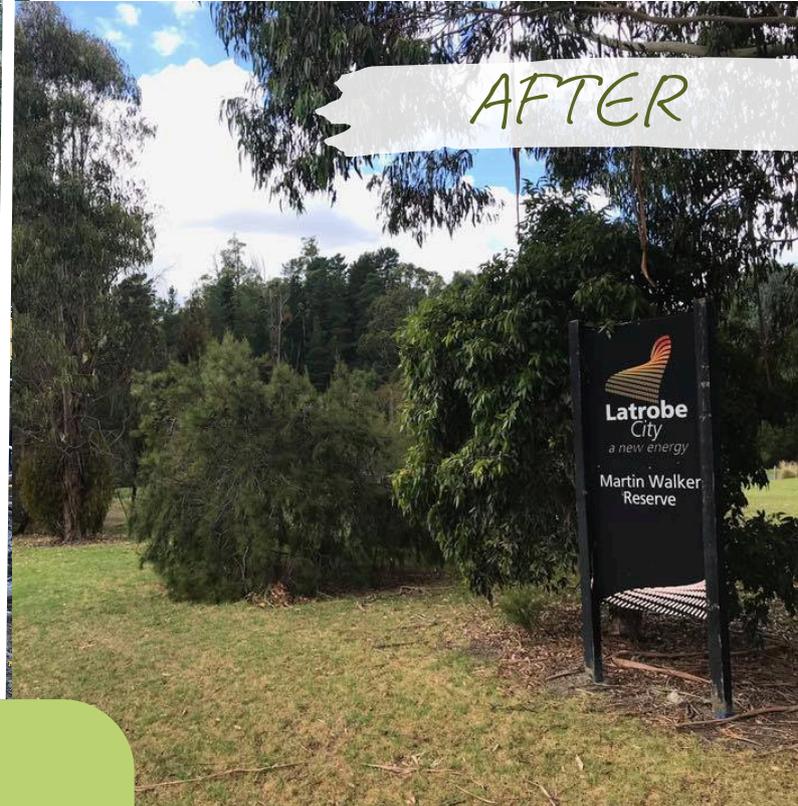
AFTER

After the banks were battered and armoured, planting helped restore the gardens for the community to enjoy.
